Fatality Report

Accident type Asphyxiation/fermentation tank
Industry Winemaking
Employee job title Laborer

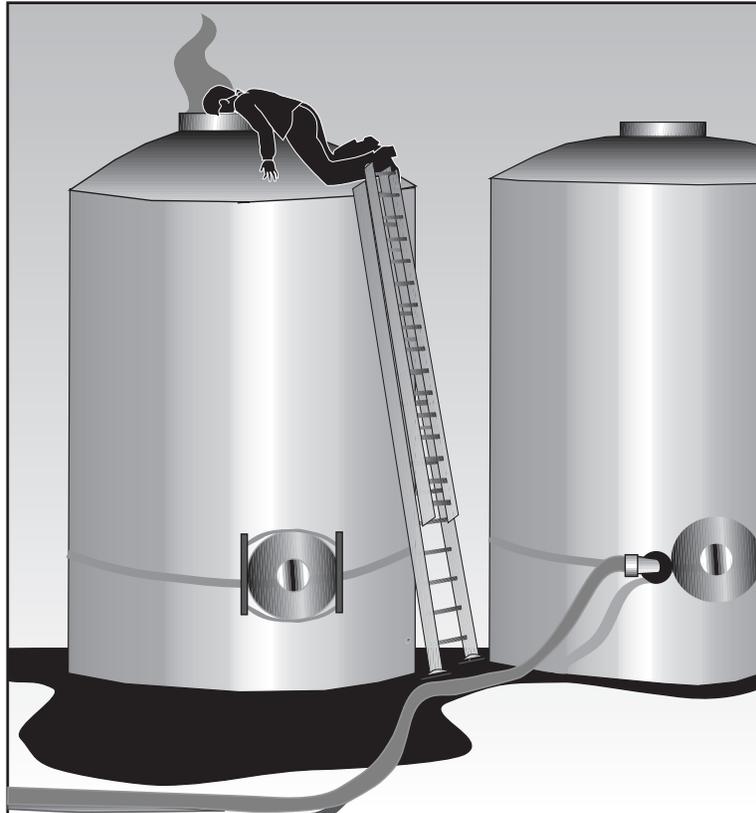
On an October day at an Oregon vineyard, a male employee, whose job included performing pump-over operations between wine fermentation tanks, was found draped across the top of a fermentation tank with one arm and his head inside the tank. The general manager/winemaker found the worker and attempted to perform CPR. Paramedics arrived and determined that the worker was dead. The coroner's report, a month later, identified the cause of death as "asphyxiation due to low environmental oxygen level."

OR-OSHA determined that the employer had committed serious violations by not conducting an evaluation of the confined spaces at the worksite, not informing exposed employees about confined-space hazards by posting signs or by any other effective means, not having a written permit-space entry program available for the employees to inspect, and not providing the hazard-control measures necessary to protect employees from harmful or hazardous conditions. Proposed penalties totaled \$18,000.

- Whether you operate an established business or a new business, find out what safety and health requirements your business is subject to and comply with them.
- Know what a confined space is and what hazardous atmospheres exist at your workplace and take measures to protect your employees.
- When employees perform tasks that involve hazardous atmospheres, ensure that they never work alone.
