Department of Consumer & Business Services  
Oregon Occupational Safety & Health Division  
Salem, OR 97310

## Fatality Report

Accident type ..... Electrocution  
Industry ..... Reforestation/timber thinning  
Employee job title ..... Owner, crew member

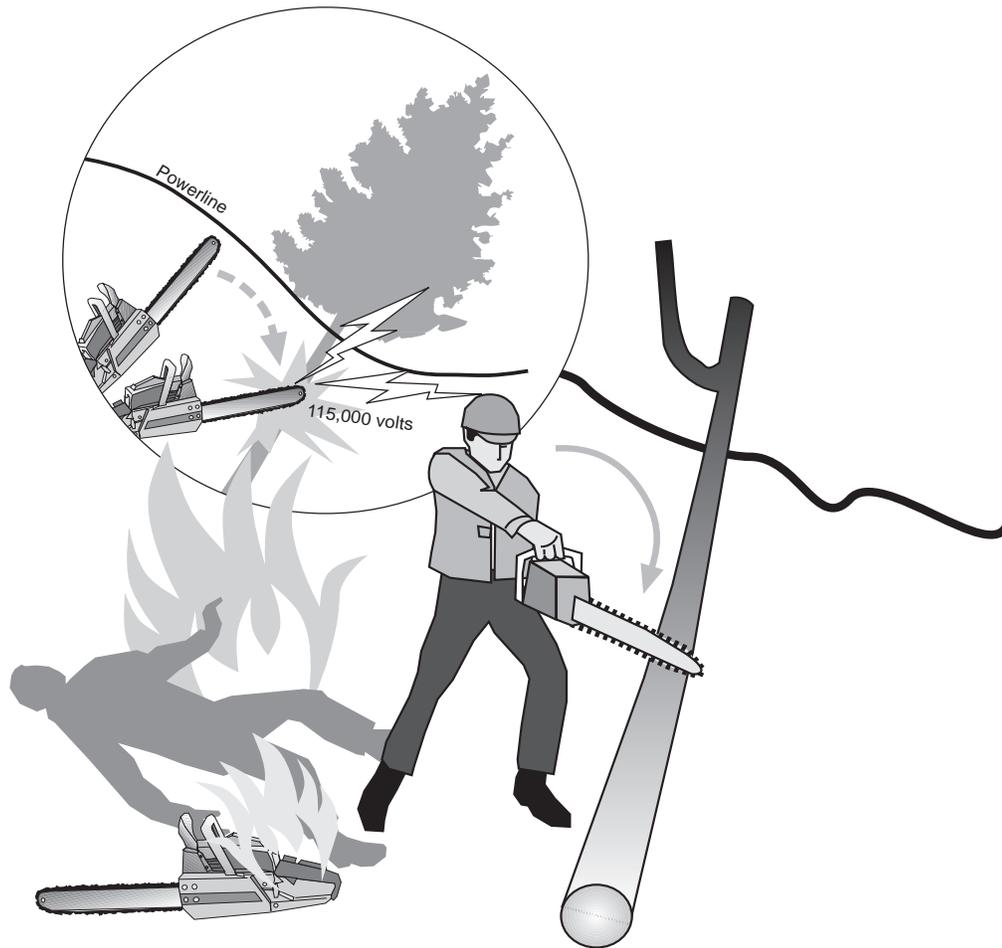
A crew of 10 was finishing a late-August day of timber thinning and brush cutting on a tract of timber. At about 3 p.m., one of the crew fell a small-diameter tree that struck and caught on a power line as it fell. The owner of the company, who was working nearby, reached out with his chain saw to cut the butt end of the hung-up tree so that it would dislodge from the power line and fall to the ground.

His chain saw exploded upon contact with the electrified tree, which carried a current of 115,000 volts. Flames from the burning saw engulfed the victim. The crew member who had dropped the tree onto the power line had been shocked as electrical current flowed through the tree, the ground, and his saw. He was able to drop his saw, which also caught fire.

Investigation revealed that the owner had not notified the power company that his crew would be falling trees within 10 feet of power lines. Employees of the reforestation/thinning crew had not been properly trained to fall trees; most of the trees that had been fallen in that tract had been fallen toward the power lines. No precautions had been taken to prevent trees from being fallen onto power lines. Also, the fallers dropped trees within one tree-length of other workers (must be at least two tree-lengths apart), and all of the trees fallen by one faller lacked undercuts and backcuts. Interviews with employees revealed that trees had been fallen onto power lines on three other occasions and that the owner was on site on those occasions. The crew had not been trained in fire-suppression techniques.

- OAR 437-006-0355(15) The employer must ensure that all precautions have been taken when falling trees near power lines.
- OAR 437-006-0028(3) The employer must notify the owner of high-voltage power lines when planning to work within 10 feet of a power line.
- OAR 437-006-0015(4) The employer must provide adequate training.
- OAR 437-006-0080(1)(a) The employer must provide fire-suppression training for employees expected to conduct fire suppression.
- OAR 437-006-0355(1) The employer must ensure that the required clearance (between or among employees) is maintained at all times when trees are being fallen.
