# SAFETY NOTES

## Fatality Report

Accident type ..... Electric shock  
Industry ..... Municipal water services  
Employee job title ..... City maintenance worker

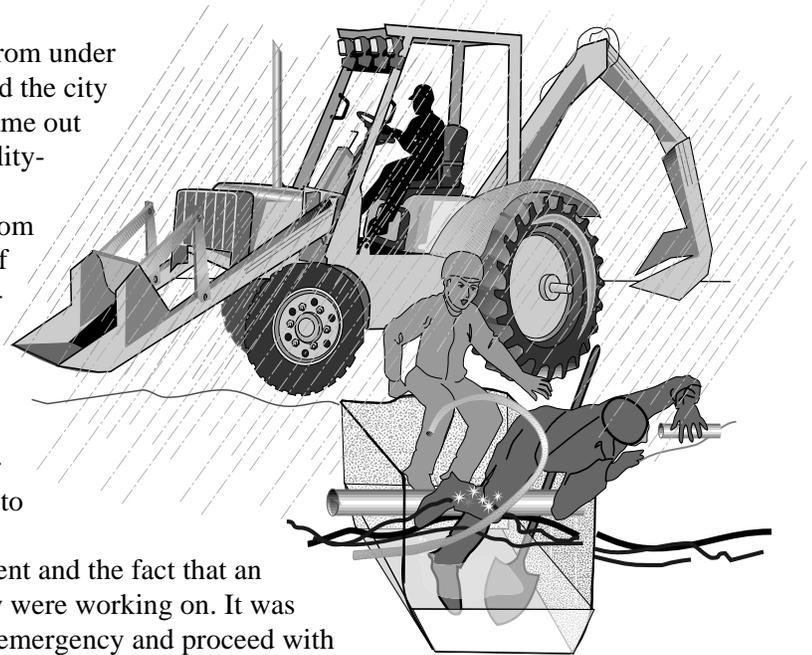
At about 3 a.m. the foreman instructed the two crew members to dig for the leaking main. At about 3:30, the locator was called to another site. The crew members uncovered three wires, later identified as 120-volt secondary power wires. When the crew members found the saddle and copper tubing and decided to replace it, they coupled new tubing to the old tubing and used the teeth of the bucket of a backhoe to "pull" the pipes through the meter box. The victim was standing in water in the trench without protective gear, holding onto the copper tubing when the coupling connecting the tubing cut into electrical wires in the trench and shocked the victim.

His co-worker jumped into the trench to help him and was also shocked and was unable to release or help the victim. The foreman then jumped into the trench and was shocked, but was able to get out. He used a wooden broom handle to push the employees free of the copper pipe. He dialed 911. Emergency technicians were unable to resuscitate the victim, who was declared dead at the hospital to which he was transported.

Investigators determined that the employer had failed to take all reasonable means to uncover and reroute or de-energize the electrical power at the excavation site and failed to provide employees adequate instruction in recognition and avoidance of underground electrical/water hazards.

- Ensure employees are thoroughly trained and have the skills and equipment to do their jobs safely.
- Give safety the highest-possible priority when making decisions about expediency in dangerous situations.
- Train for appropriate procedures when electrical shock does occur: don't compound injuries and fatalities.
