# SAFETY NOTES

## Fatality Report

Accident type ..... Crushed by vehicle  
Industry ..... Rendering/hauling  
Employee job title ..... Driver/skinner

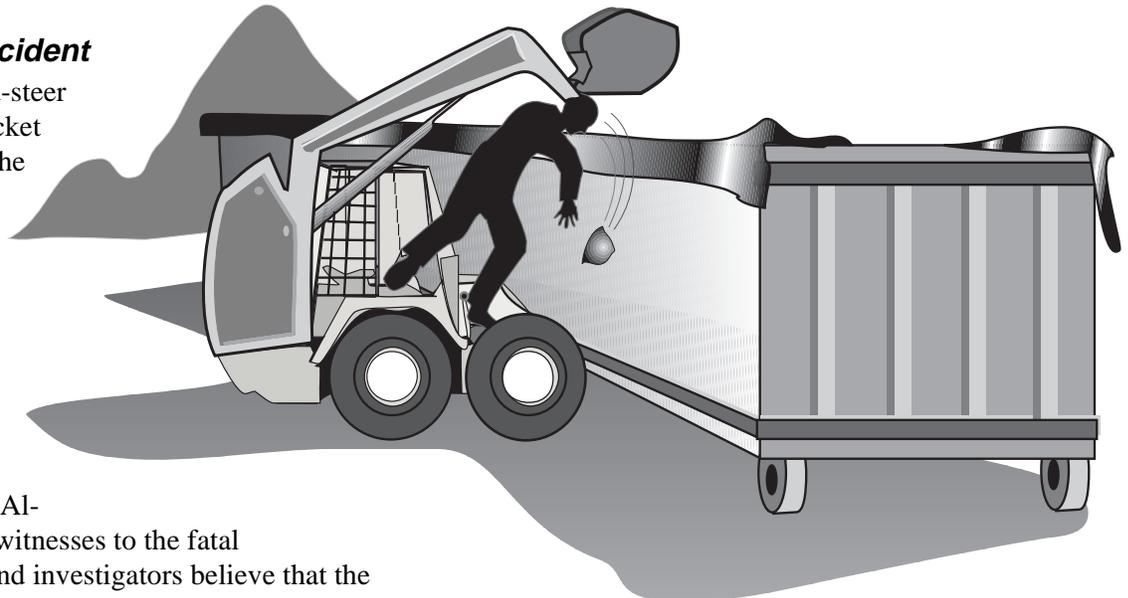
The driver of a skid-steer loader with a front bucket (843 Bobcat), was in the process of dumping layers of sawdust and grease residue into a large, outdoor sanitation-company bin. The sanitation company accepted the grease residue on the condition that it was layered with sawdust. Al-

though there were no witnesses to the fatal accident, employees and investigators believe that the driver was engaging in a common practice of loader drivers at the worksite: checking sawdust levels in the bin by leaning out of the loader, which was parked with its bucket raised against the sanitation-company bin, and peering into the bin.

Accident reconstruction indicated that the driver, whom another employee had seen exiting the cab of the loader earlier, had, at some point, turned off the engine with the boom and bucket raised overhead, placed the seat safety bar in the up position, stepped out, and leaned forward to look into the bin.

Investigators believe that the driver may have contacted the left-side foot control, bringing the bucket boom down and pinching his head between the bin and the underside of the pivot point for the boom. The driver was wearing a hardhat at the time of the accident; marks on the hat appeared to match the boom pivot supports.

The practice of employees standing under the raised bucket of the loader had not been disallowed by management, although employees had been "warned" not to stand under the bucket. The vehicle involved in the employee death was being operated in an unsafe condition: neither the parking brake nor the manual safety interlock attached to the safety seat bar was working at the time of the accident, and the vehicle was not checked for mechanical safety at the beginning of each work shift. Operators of the loader had not received training and had not read or been shown the operator's manual for the loader.
