Accident Report

Accident type Fall from structure
Industry Home construction/roofing
Employee job title Estimator/roofing company

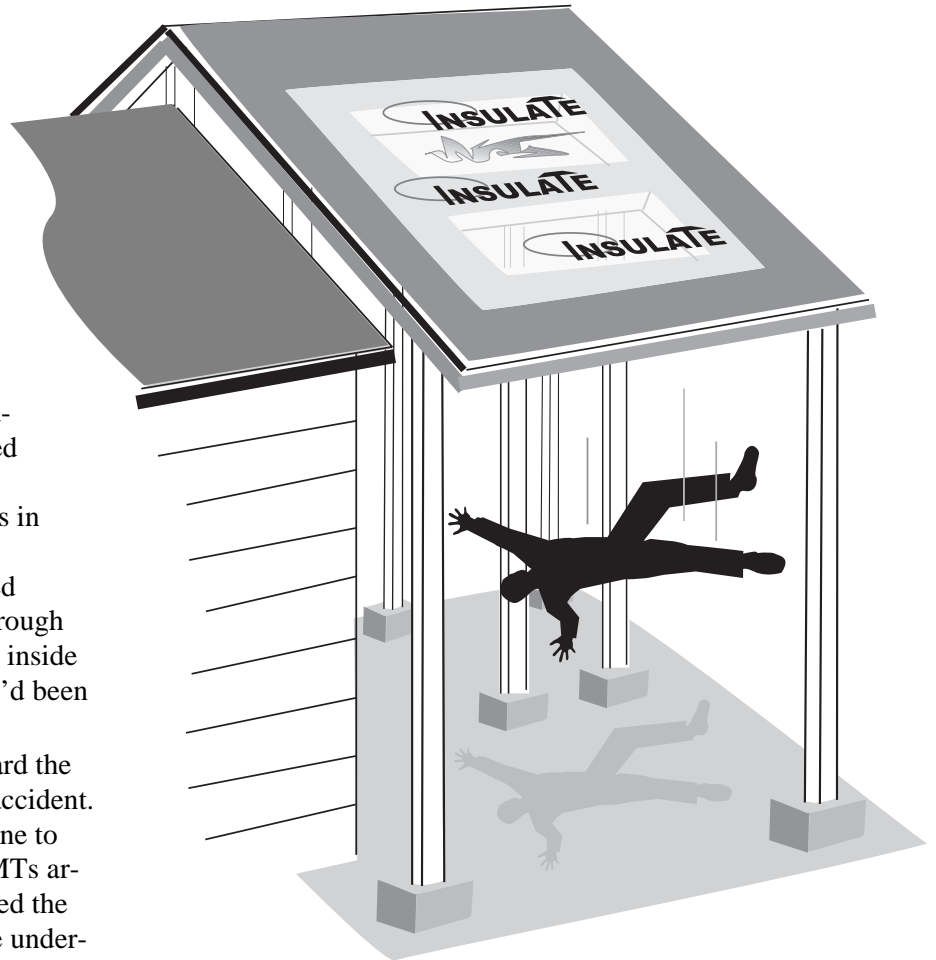
The estimator went onto the roof with his tape measure. He was not accompanied by construction-crew members. The estimator was unaware that the contractor had used a sheet of thin insulating material to cover three two-foot-by-six-foot skylight openings in the roof of the new addition because it had rained the day before. The estimator stepped onto the thin insulating material and fell through one of the skylights. He landed on his back inside the structure, about 15 feet below where he'd been standing on the roof.

The employer failed to effectively cover the skylight openings on the roof or to provide adequate warning of the hazard.

- CFR 1926.501(4)(i)
- CFR 1926.502(i)(2)
- CFR 1926.502(i)(4)
