Electrician falls from the bucket of an aerial lift

Installation technician dies when aerial lift tips over

Worker contacts high-voltage line in aerial lift

Worker crushed under scissor lift platform

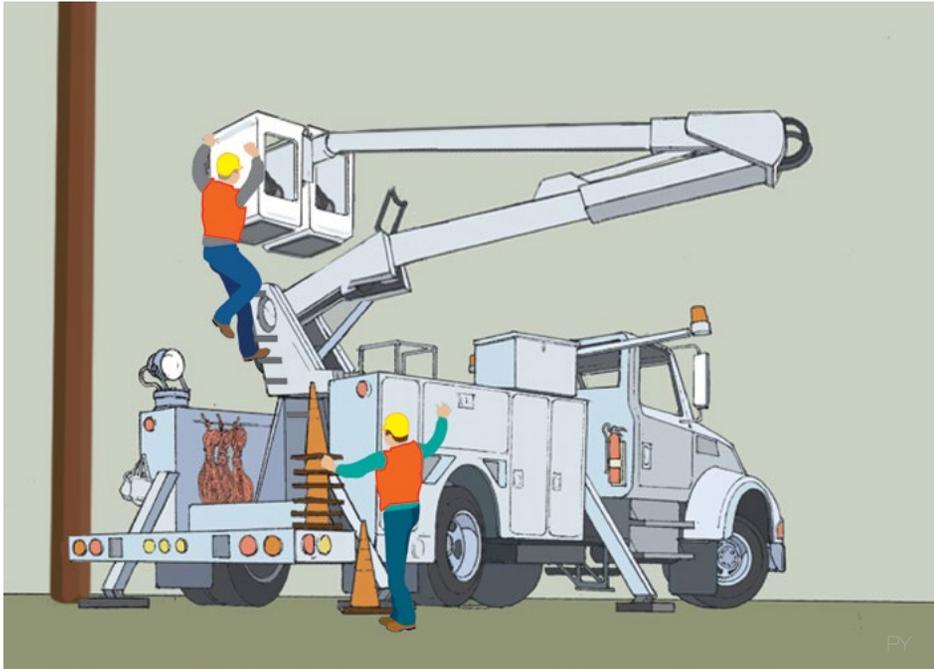
(Safety Notes: December 2014) Two journeyman electricians were relocating power poles to service job trailers at a landfill. They were using an older digger derrick truck that had a boom and an auger for drilling holes. The end of the boom had a motorized hoist for setting the poles and there were two side-by-side buckets on a separate onboard aerial work platform at the end of the boom.

They picked up the second pole using the hoist cable at the end of the digger derrick boom. A synthetic-fiber lifting strap was wrapped around the pole and attached to the hook. Another rope was attached to the eye of the strap so that the strap could be loosened from the ground. After they set the pole, one of the electricians was unable to remove the strap by tugging on it, so he decided to remove it from the aerial platform.

He climbed the onboard fixed ladder, grabbed the top of the bucket with both hands, and placed one foot on its outside lower lip. As he swung his other foot over the top of the bucket, the bucket-leveling cable, which kept the bucket level as the boom was raised and lowered, broke under his weight. The bucket swiveled vertically and he fell, hitting parts of the truck and landing on the ground. His injuries included two fractured vertebrae and soft tissue damage.

One of the electricians said that he never performed a pre-operation inspection or thorough periodic inspection on the digger derrick or the aerial boom lift. Just after the incident, workers were unable to find the lift's maintenance manual, but later discovered it in the truck, soaked in hydraulic fluid and unreadable. Also, the company failed to report the incident to Oregon OSHA within 24 hours.

- **437-003-0415(1):** Equipment and rigging were not inspected and maintained in safe operating condition.
- **437-003-0465:** The manufacturer's operation and maintenance manual were not available and the operating instructions and maintenance procedures were not followed.
- **437-001-0700(21)(c):** The employer did not report the incident to Oregon OSHA within 24 hours.

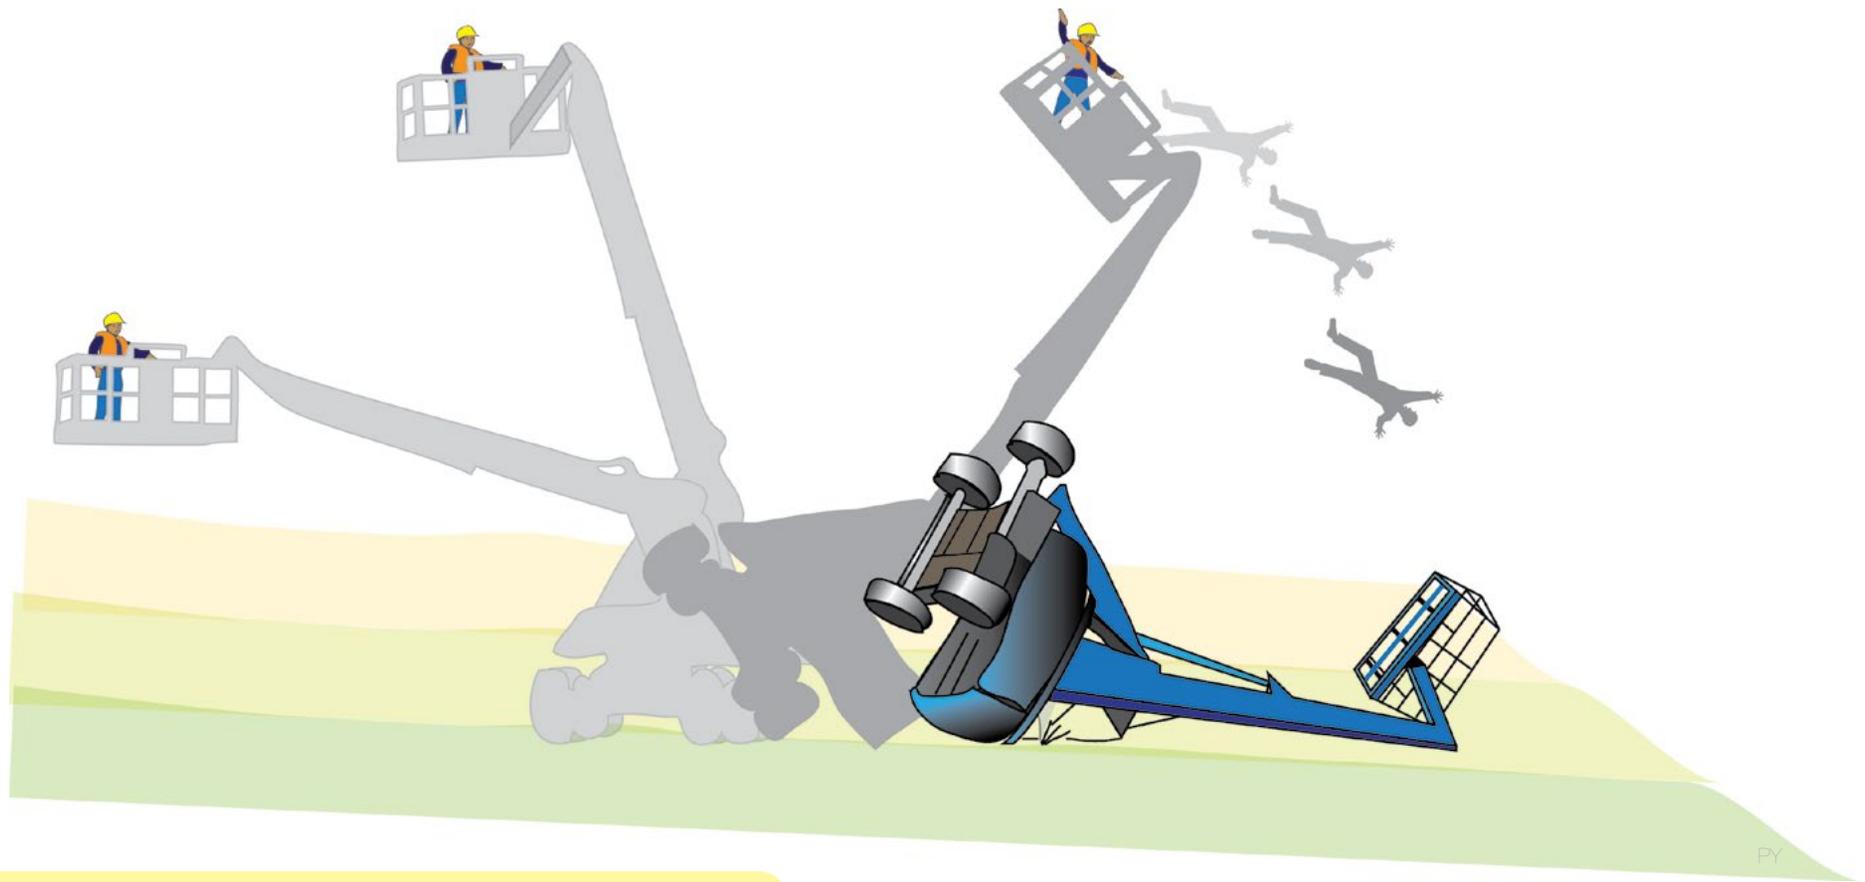
He was operating the lift on an 8- to 10-degree slope with counterweight on the downhill side; however, the manufacturer's instruction warned against operating the lift on a hillside. Although he was wearing a body harness for fall protection, he did not attach his lanyard to one of the manufacturer's approved anchorage points on the platform.

As the technician raised the platform to its maximum height with the boom retracted, the lift suddenly tipped over, throwing him 10 feet from the platform.

- **437-003-0073(1):** The employer did not follow the manufacturer's operating and maintenance instructions when using the aerial lift.
- **437-003-0073(2):** Workers were not using personal fall protection when they were working in the boom-supported aerial lift.
- **1926.502(d)(15):** Anchorages used for attachment of personal fall arrest equipment were not capable of supporting at least 5,000 pounds per employee.

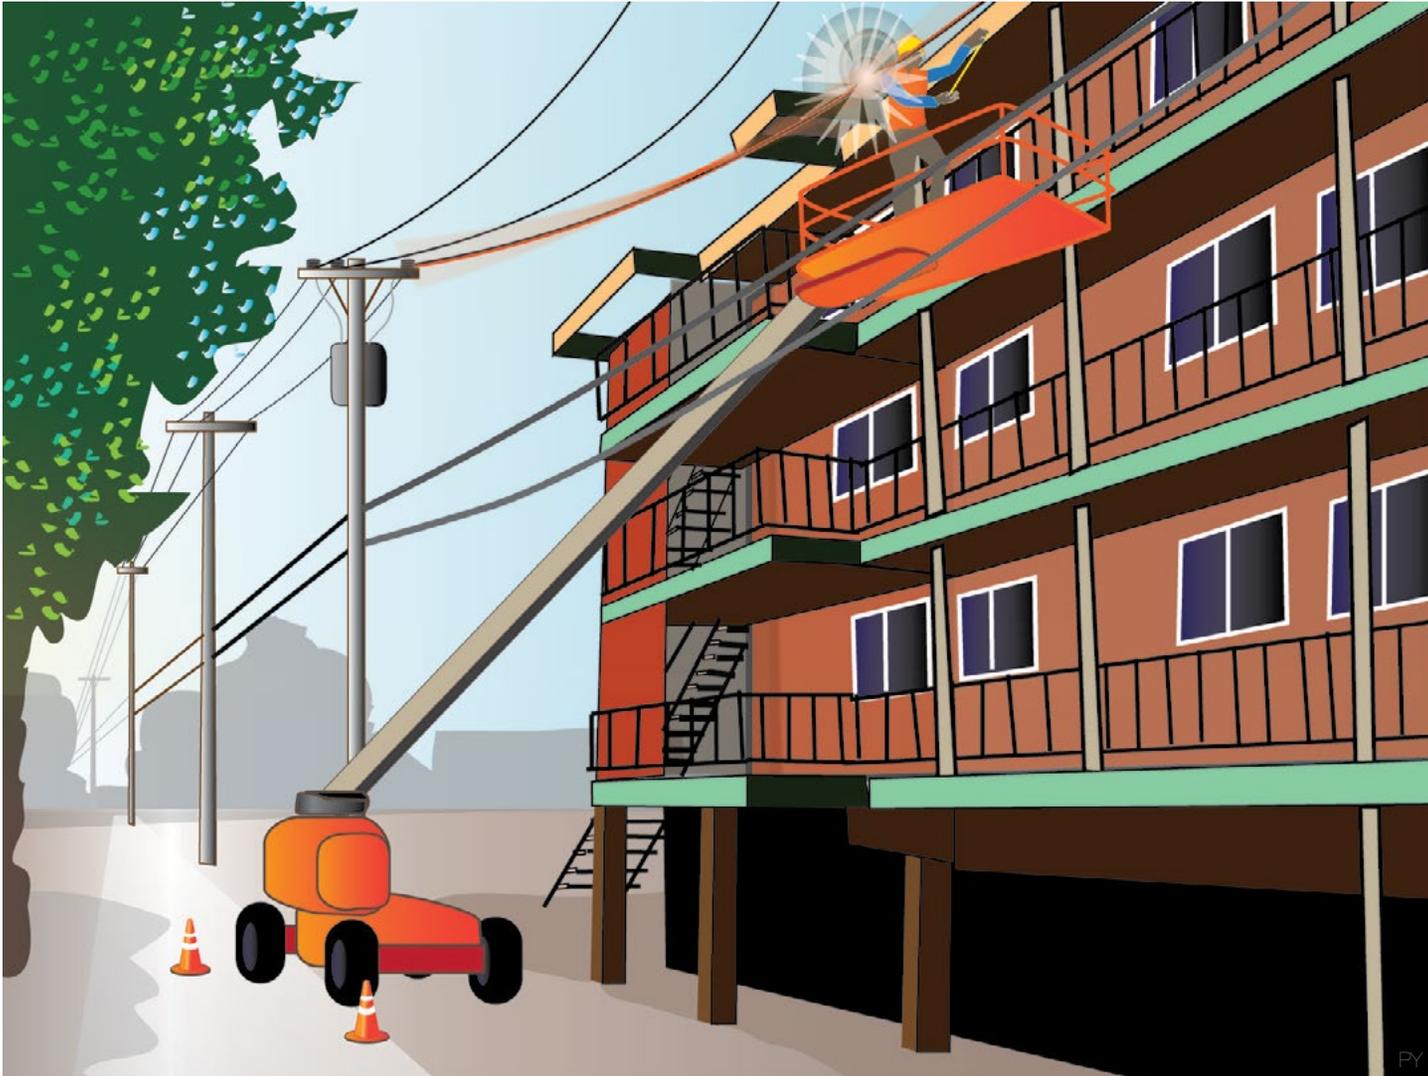
They decided to use an aerial lift that the general contractor rented (but which was not working correctly) to get to the work area – about six feet from a 7,200-voltage power line. To do the work, one of the workers agreed to be a spotter who would watch for approaching traffic and make sure the lift platform, which measured eight feet by four feet, did not touch the power line.

When the foreman saw the two workers go up in the lift with lumber that they were going to cut for an overhang, he told them to come back down and make the cut on the ground. After they made the cut, one of the workers went back up in the lift to take a measurement. As he was taking the measurement, his shoulder touched the high-voltage line. Sparks flew in all directions as he went into convulsions and fell to the floor of the lift.

- **437-003-0047(2):** The subcontractor allowed his employees to enter and work within the restricted space surrounding an overhead high-voltage line.
- **437-001-0760(7)(a):** The subcontractor did not promptly replace or repair defective equipment.
- **437-001-0760(1)(b)(B):** The general contractor did not require his employees to conduct their work in compliance with all applicable safety and health rules.
- **1926.454(a):** The subcontractor did not ensure that his employees were trained by a person qualified to recognize hazards associated with the aerial lift.

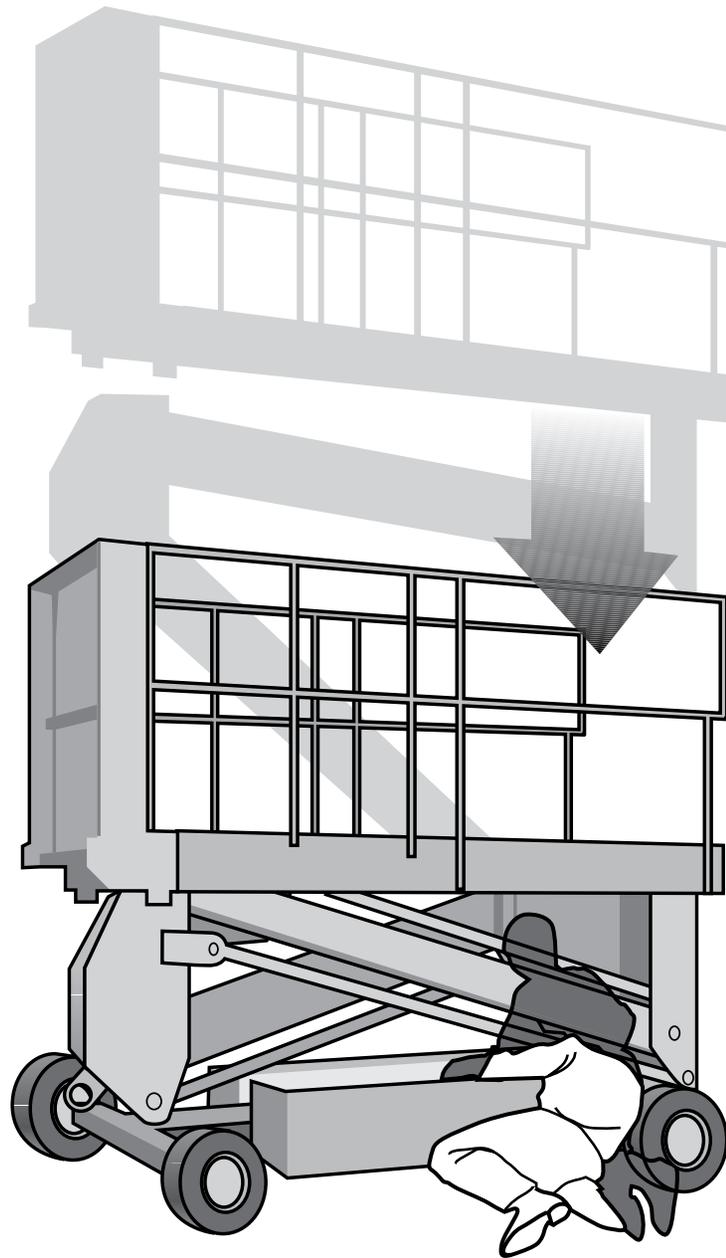
He raised the platform and was reaching toward the battery compartment across the metal enclosure that houses the lift's toggle controls when it suddenly dropped and pinned him near the control panel. His father found him and called 911 but he died by the time emergency responders arrived.

The lift's emergency valve, hydraulic hoses and fittings, and electrical wiring system were inspected after the accident and found to have no defects, but the on-off key switch had been bypassed to allow the operator to use the toggle switches without the key. The battery charging system was missing a fuse that would prevent the system from accepting a charge and the spring-loaded toggle switches that controlled the boom did not have guards to prevent them from being moved unintentionally. There were no lockout procedures, the boom had not been blocked to prevent it from descending during maintenance work, and the father had not reviewed the operator's manual with his son or the other employees.

- **437-001-0760(1)(b)(D):** The employer failed to ensure that employees did not remove a required safety device, guard, notice, or warning.
- **1910.147(c)(4)(i):** Procedures were not developed, documented, and used for the control of potentially hazardous energy.
