**Oregon OSHA**  
**OSHSPA State Plan Report**  
**Renée Stapleton, Acting Administrator**

**OSHSPA members meeting 8/30/2022**

## **Notable Case:**

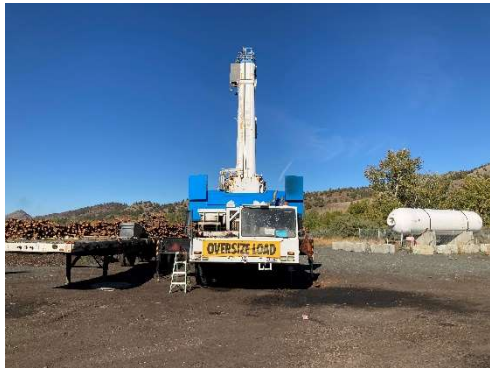
The Demag AC 335 165-ton mobile crane.

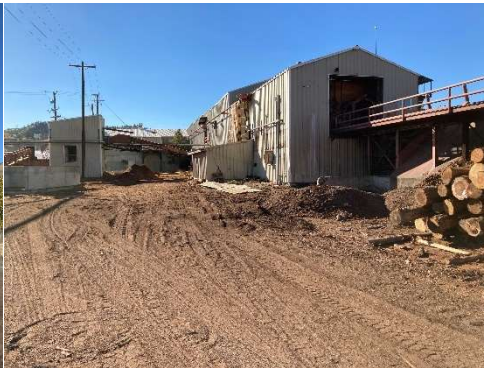
At first, the co-worker thought that the owner started the crane to warm it up and that they would ride together in the Dodge pickup and move the two lumber company trucks. But the owner began driving the crane toward the pick location. As he approached the two trucks he tried to maneuver the crane around them. But the back of the

crane swung wide and the boom, which was upright but fully retracted, contacted the two 19,900-volt overhead power lines.

The route the crane traveled to the service pick location (powerlines, upper left).

- The owner said he should have marked the location of the power lines on the ground and used a spotter.
- The crane manufacturer required the crane's boom to be locked in an upright position when the crane was traveling with counterweights to prevent overloading the axles. The owner said that the crane's rear and middle axles steer, and when turning a corner, the rear of the crane will swing wide.

- *29 CFR 1926.1411(b)(1), Powerline safety:* The employer did not ensure that the mobile crane's boom was lowered enough to ensure that at least six feet of clearance was maintained between any part of the crane's boom and the 19,900-volt powerlines.
- *29 CFR 1926.1411(b)(4), Powerline safety:* The employer did not ensure that a dedicated spotter was in position and used before the crane moved closer than 20 feet to the 19,900-volt powerlines.

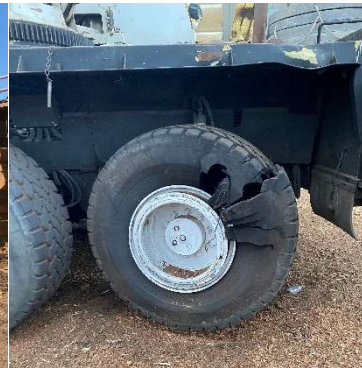
However, the owner was unaware that the crane's brief contact with the power lines sent 34,500 volts down the boom and through the steel-belts in the crane's tires, which became extremely hot. The heat dramatically increased the air pressure in the tires and caused the chemical bonds in the tires' rubber compounds to break down (a condition called pyrolysis).

The co-worker was standing about 15 feet behind the crane when a rear tire suddenly exploded, knocking him to the ground. But the owner was standing only three feet from the tire and the explosion hurtled him 34 feet away.

The ruptured rear tire that injured the employee.
