# SAFETY NOTES

## Fatality Report

Accident type ..... Fall  
Industry ..... Cable installation  
Employee job title ..... Cable splicer

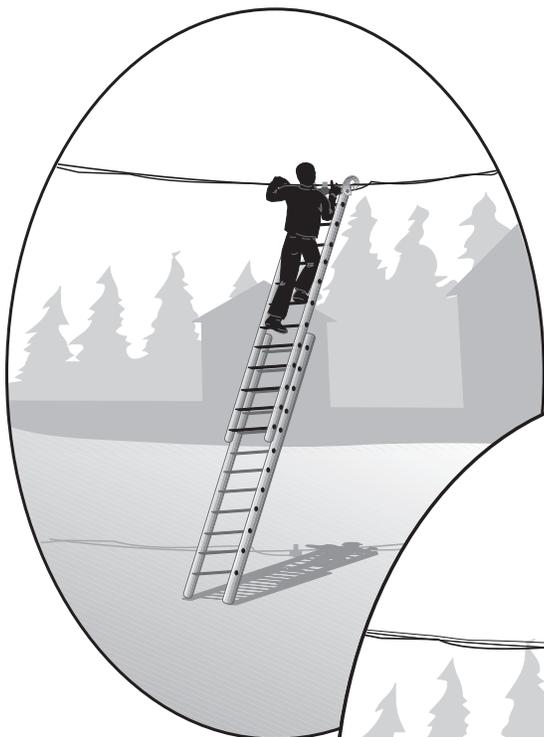
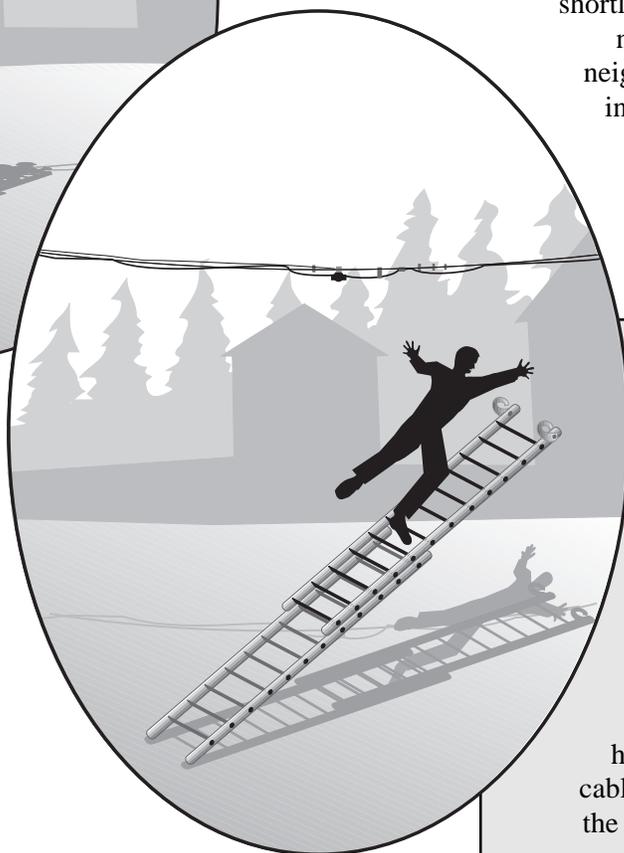
The cable splicer was attempting to relocate a cable TV service tap to a nearby utility pole in a suburban Portland neighborhood. To gain access to the cable connection terminals, the splicer used an extension hook ladder hung from the overhead cable strand. The ladder was not secured to the cables and became disconnected from the cable strand, causing the splicer to fall to the pavement. The splicer was not wearing a hard-hat at the time of the accident. There were no witnesses to the accident, but shortly after it occurred, a passing motorist noticed the injured worker and alerted neighbors and a construction crew working nearby. Emergency personnel were called to the scene to provide medical attention. The splicer had suffered traumatic head injuries in the fall and died at the scene.

Investigators determined that the cable splicer was not wearing a hard-hat or a high-visibility vest for working in traffic. Traffic controls were not in place to protect the area where the splicer was working. The worksite had not been evaluated for safety hazards. A safety strap had not connected the ladder to the cable strand. Adequate supervision of the employee at the work site had not been provided by the employer.
