HAZARD ALERT

February 2005

Metal Halide Lights

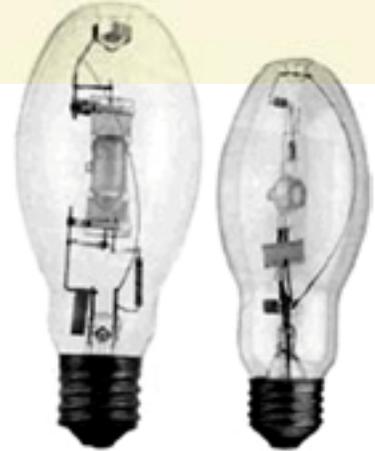
The source of the injuries was the 400-watt metal-halide lamp. The protective outer jacket to the lamp was broken but the bulb's inner quartz tube continued to illuminate, and it emitted ultraviolet (UV) radiation. This radiation caused serious skin and eye inflammation.

Measurements of UV radiation levels were taken at various locations throughout the gym. Sampling of the UV light source using a similar metal-halide bulb with a broken protective envelope was performed in attempt to replicate employee exposures. UV exposures throughout the gym ranged from 0.1 microwatts per square centimeter ($\mu\text{W}/\text{cm}^2$) in the corners of the gym, to 6.0 $\mu\text{W}/\text{cm}^2$ beneath the bare tube. At an exposure intensity of 6.0 $\mu\text{W}/\text{cm}^2$, a full-day exposure according to published guidelines of American Conference of Governmental Industrial Hygienists (ACGIH) would occur in only 8 minutes.

- Education and training
- Regular inspection of lights
- Use commercially available self extinguishing bulbs
- Use an additional glass or plastic lens that fits under the light and envelop

The 2005 National Electric Code Article 410.4(E) has newly adopted requirements for luminaries for indoor sports, mixed use and all purpose facilities. In brief, the article provides that mercury-vapor or metal-halide bulbs located in playing and spectator areas, that are subject to physical damage, must be of a type that protects the lamp with a glass or plastic lens. Open bulbs are not permitted. An additional external screen or cage used to prevent a ball from striking the bulb is permitted, but is not a substitute for the required lens.
